## CASE STUDY

SAN JUAN GENERATING STATION  
FARMINGTON, NEW MEXICO

### RETROFIT A QUICKER OPTION THAN REPLACEMENT

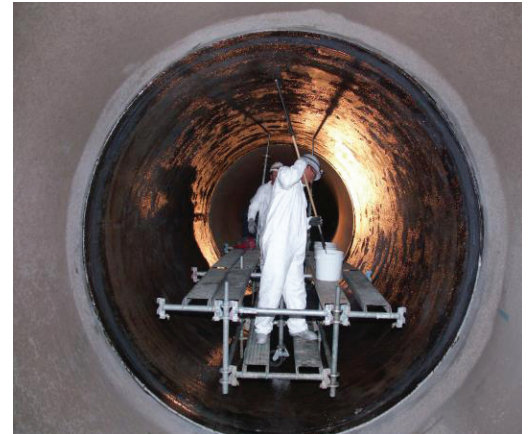
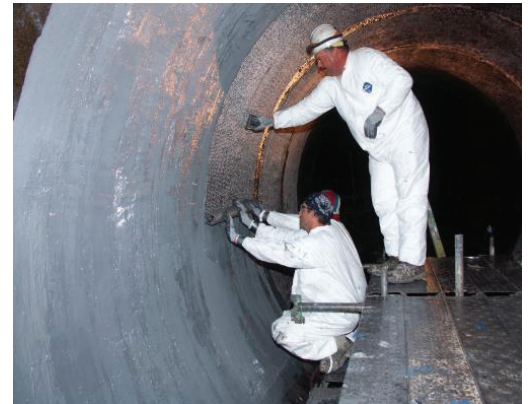
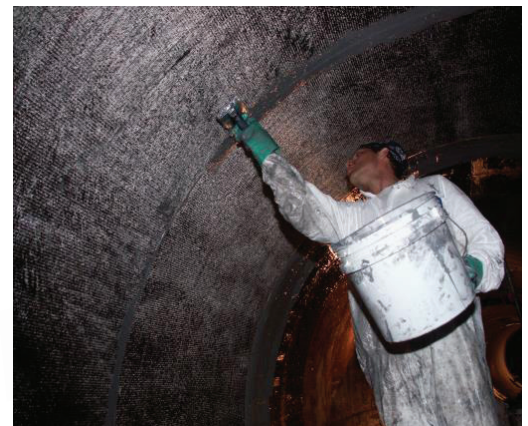
Several prestressed concrete cylinder pipes (PCCP) at the power plant had failed due to the corrosion of prestressing wires and the high pressure in the pipes. Due to the long downtime required for replacement, and the high replacement cost, this option was not acceptable to the management at the power plant. A cost-effective repair option that could be implemented during the short outage time was required.

Pipe retrofit technology using DowAksa CarbonWrap® was presented to the client. This option was gladly accepted by the management as the best solution and it was implemented on the job.

Eight hundred linear feet of the ten-foot diameter recirculation pipes at two different locations (hot line and cold line) were retrofitted by wrapping them with two layers of DowAksa CarbonWrap®. The entire project, including mobilization, took only 11 days to complete.
