DOWAKSA CarbonWrap®

CASE STUDY

SEVERAL BRIDGES
NORTHEASTERN UNITED STATES

REPAIRING HIGHWAY BRIDGE COLUMNS COST-EFFECTIVELY

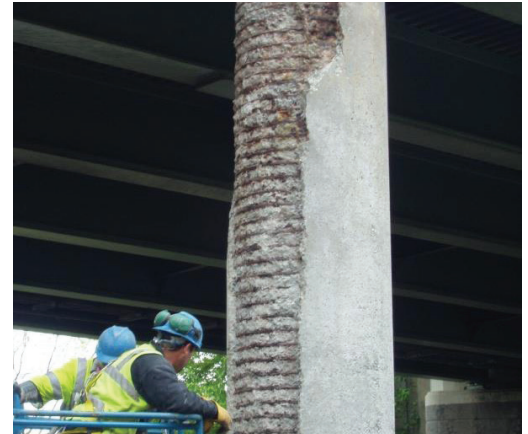
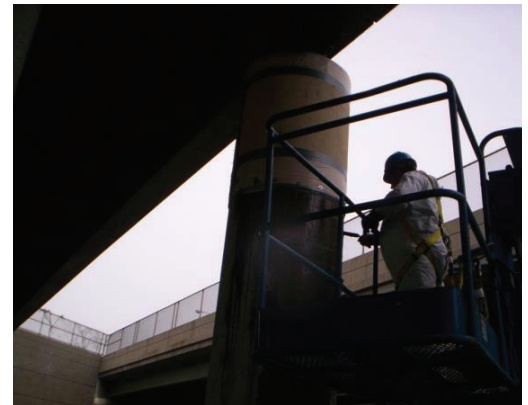
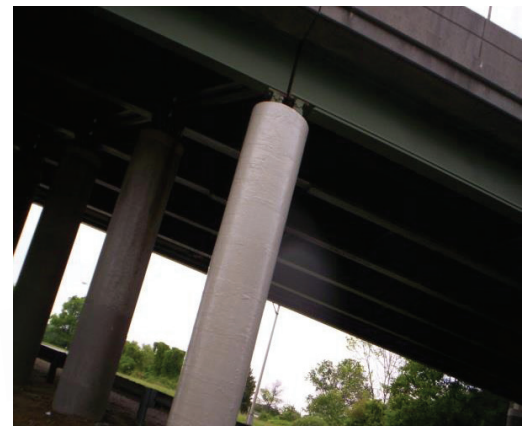
Many bridges in the Northeastern United States suffer from severe damage due to corrosion of rebar in many parts of the structure including columns. Replacement of such a large inventory of damaged columns is not a practical solution. Furthermore, many conventional repair methods, such as patching with new concrete and welding rebars, have proven ineffective, time consuming, and costly.

DowAksa CarbonWrap® provided an effective and economical solution involving filling the spalled areas with high strength PolyCon500™, and wrapping the column with DowAksa CarbonWrap® fabric. The polymer-based PolyCon 500™ created a super strong bond with the old concrete, eliminating the possibility of failure at the cold joint. The high-strength DowAksa CarbonWrap® fabric made up for the lost steel area due to corrosion and protected the steel from future corrosion caused by deicing salts, through sealing of the core concrete and steel.
