## CASE STUDY

THE HOPKINTON BRIDGE  
HOPKINTON, MASSACHUSETTS

### UNIQUE DESIGN USED TO ENCAPSULATE BRIDGE

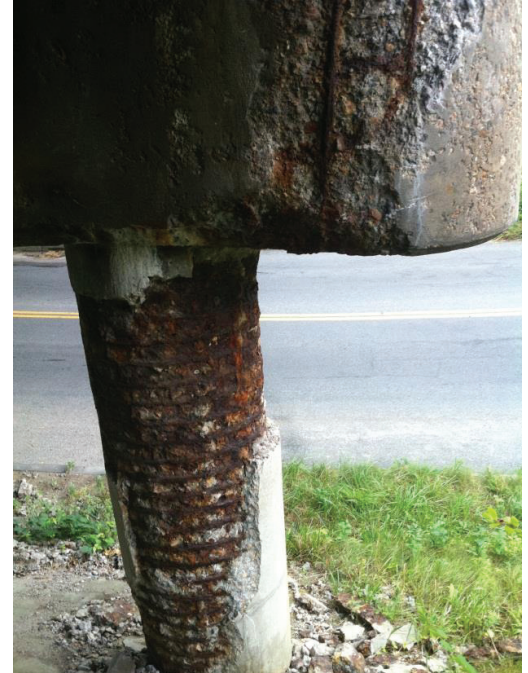
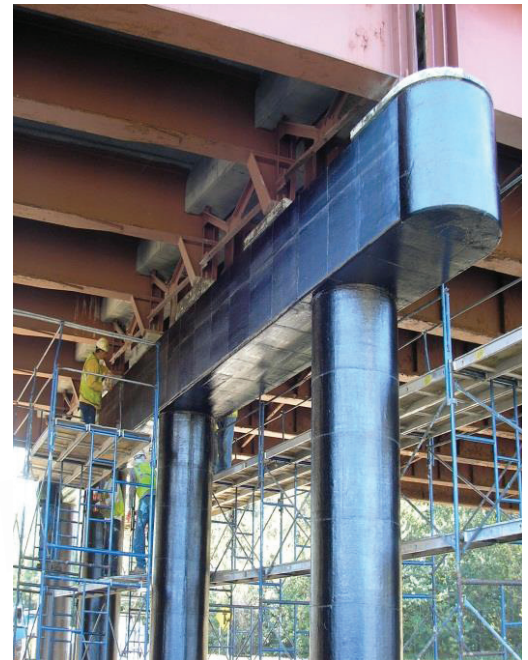
Leakage from the expansion joints in the Hopkinton Bridge had completely eroded the cover concrete on the cap beam and the bent underneath. Major spalling and severe corrosion of the rebar were present all over the columns and the bent cap. The Massachusetts Department of Transportation approached DowAksa CarbonWrap® for a design-build approach to the repair and upgrading of this structure.

DowAksa CarbonWrap® designed and installed a unique solution, combining carbon laminates and fabric to strengthen the bridge for shear and flexural forces. Special high-strength polymer concrete was used to repair and patch all spalls in advance of wrapping with carbon fabric. A unique design concept was utilized in this bridge as a showcase to stop corrosion. The approach consisted of completely encapsulating the bridge, preventing any oxygen or electrolytes from getting into the concrete structure beneath the wrap to starve the system of the primary elements of an electrochemical corrosion.
