DOWAKSA CarbonWrap®

CASE STUDY

SAN FRANCISCO PUBLIC UTILITIES
SAN FRANCISCO, CALIFORNIA

REPAIRING STEEL PIPES WHEN WELDING IS NOT AN OPTION

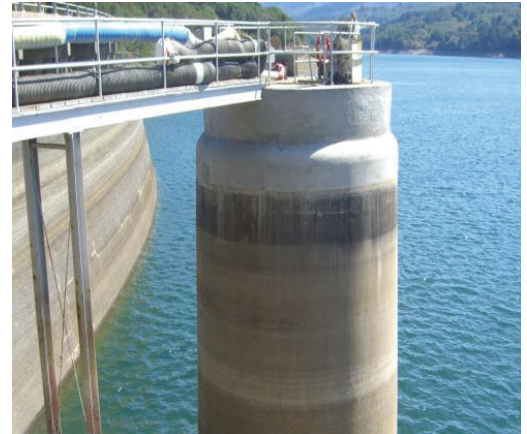
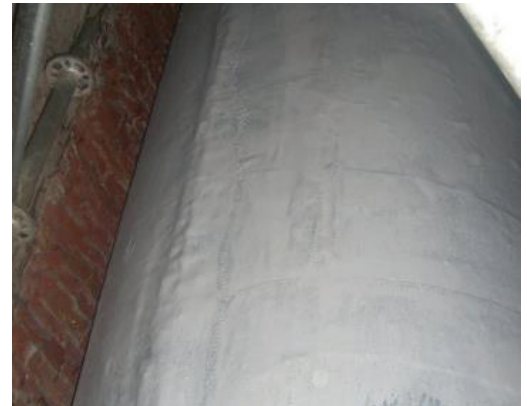
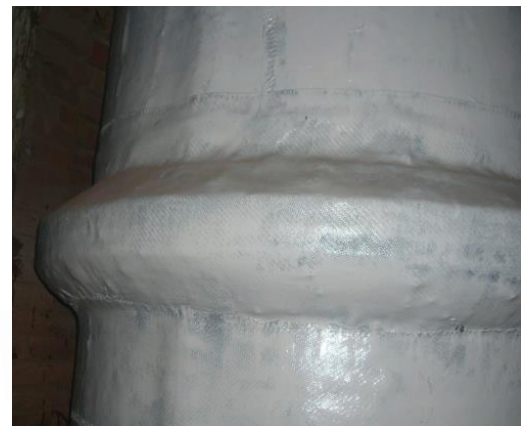
The San Francisco Public Utilities Department faced a very difficult problem. When they tried to sandblast a very old riveted steel stand pipe inside a tower behind a dam, due to corrosion and thinning of the pipe's walls, the sandblasting resulted in numerous holes and leaks in the pipe. Because the pipe was too close to the tower walls (about 3 inches from the walls), welding was not an option. San Francisco Public Utilities then contacted DowAksa CarbonWrap® for a quick repair method.

The solution in this case involved wrapping the pipe in two layers of DowAksa CarbonWrap®, essentially encapsulating the entire pipe. The leaks completely stopped.

Furthermore, applying two layers of the DowAksa CarbonWrap® significantly increased the pressure rating of the pipe and protected it from further corrosion.
