DOWAKSA CarbonWrap®

CASE STUDY

PHOENICIAN RESORT
SCOTTSDALE, ARIZONA

REPAIRING CONCRETE COLUMNS IN PARKING GARAGES

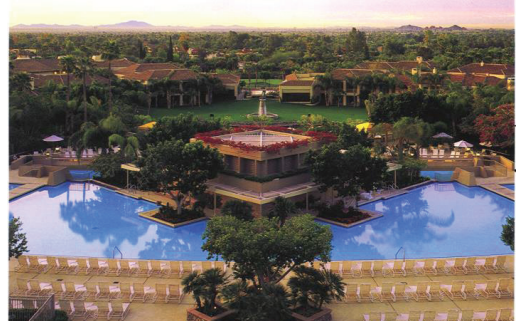
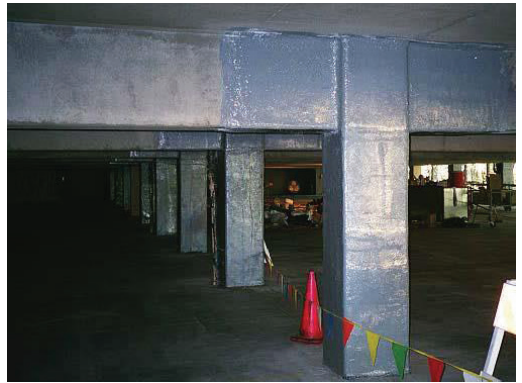
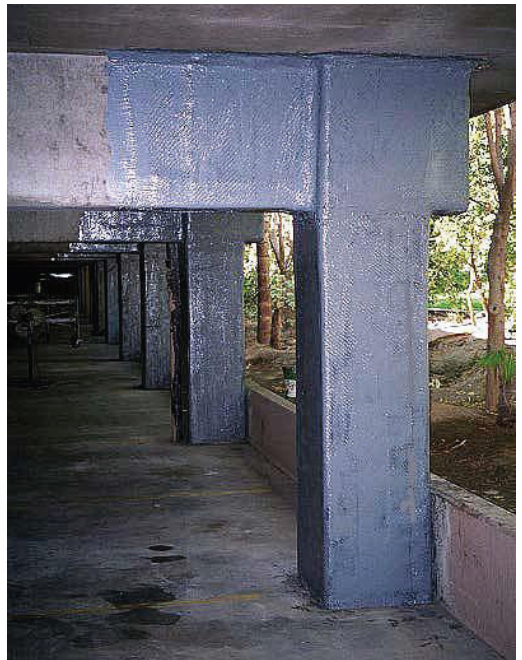
The Phoenician Resort is a luxurious vacation property with a large on-site parking garage for its guests. Over time, the garage's columns were damaged due to impact from cars and exposure to the climate. The damage to the columns was evident by the cracks on the concrete surface.

With DowAksa CarbonWrap®, the columns were simply wrapped, preventing further crack growth. This solution was not only inexpensive, but also aesthetically non-invasive, thereby maintaining the looks of the original garage.
