# CASE STUDY

## *Repairs Complete Despite Rising Tides and Rainstorms*

### **Innovative Engineering Restores Seawater Discharge Pipe**

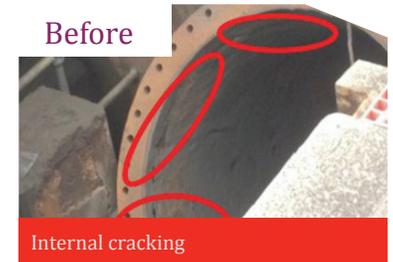
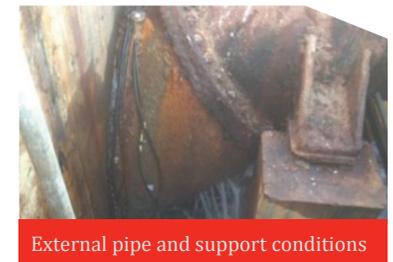
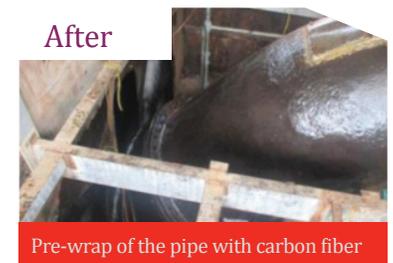
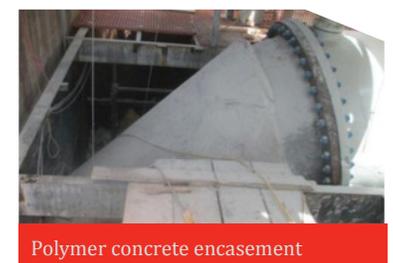
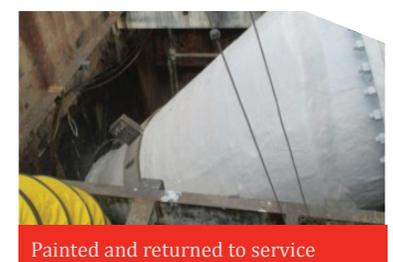
DowAksa offered a less disruptive – and less costly – alternative. First, the exterior of the pipe was pre-wrapped with carbon-fiber fabric. Then, because of the awkward location of the embedded pipe, polymer concrete was poured into a customized form that encased the original pipe. This was the first time this method was used, but the flexibility of the technology enables such customization and the results proved very effective. The formed polymer concrete was then wrapped with 10 layers of carbon-fiber-reinforced fabric – basically creating a second, stronger pipe around the original patched pipe. Finally, a stainless steel clamp was added for additional support to enable the routine maintenance of the pump in the future.

The repairs were further complicated by the fact that much of the work could only be completed during low tides. To prevent additional delays due to a number of local rainstorms, the contractor constructed a tent over the work area.

Following plant protocol, the restored pipe was tested under high water pressure to check for any leaks that might occur when put back into service. All seals held tight and continued to show good results one year later (at the time of this publication).
