## CASE STUDY

EL PASO WATER DEPARTMENT  
EL PASO, TEXAS

### HELPING TO KEEP THE WATER FLOWING

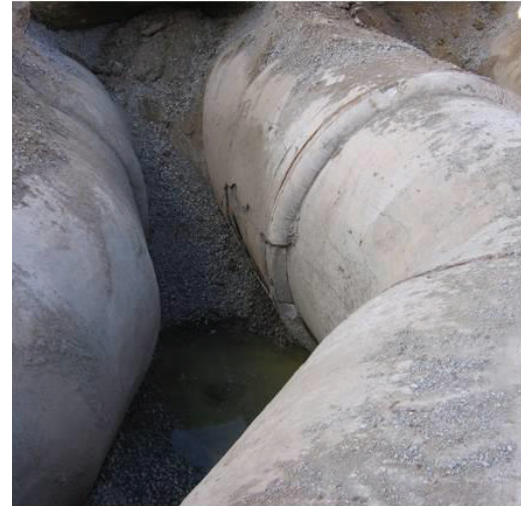
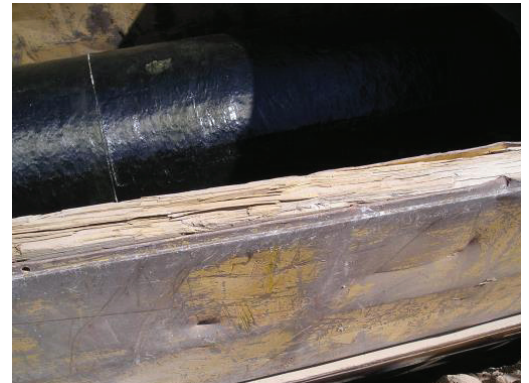
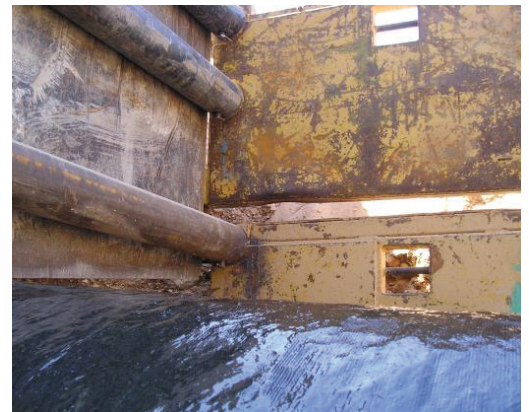
One of the 48-inch diameter force mains of the City of El Paso was leaking at several locations. Due to the importance of continuity in providing water to customers, the city could not afford to remove the pipe from service. Wrapping the pipe externally with DowAksa CarbonWrap® to stop the leak was the method of choice for the city to mitigate the problem.

The 48-inch diameter line was excavated to allow wrapping with DowAksa CarbonWrap®. The pipe was then cleaned and primed in preparation for wrapping with carbon.

The pipe was wrapped with two layers of DowAksa CarbonWrap® over its full circumference to completely encapsulate the pipe and eliminate any leak. The area was then backfilled with regular local fill.
