DOWAKSA CarbonWrap®

CASE STUDY

CENTRAL ARIZONA PROJECT
PHOENIX, ARIZONA

RETROFITTING PIPE FROM THE INSIDE OUT

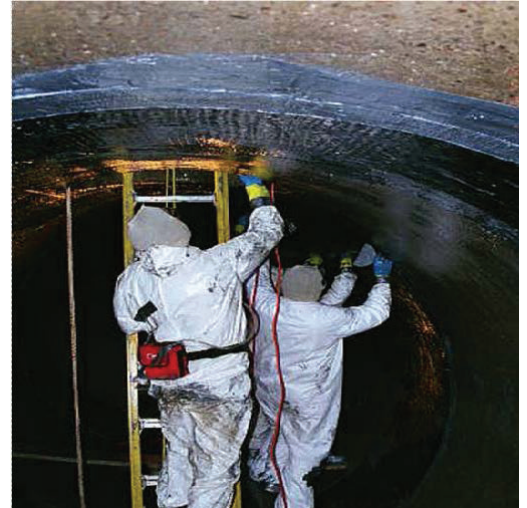
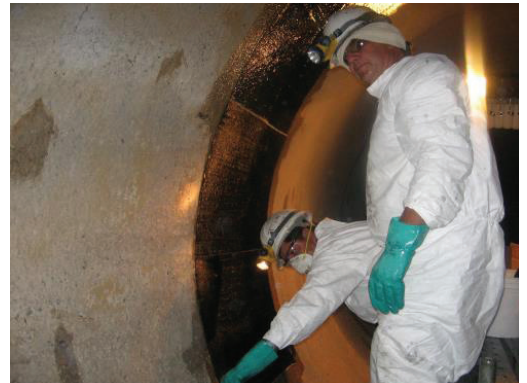
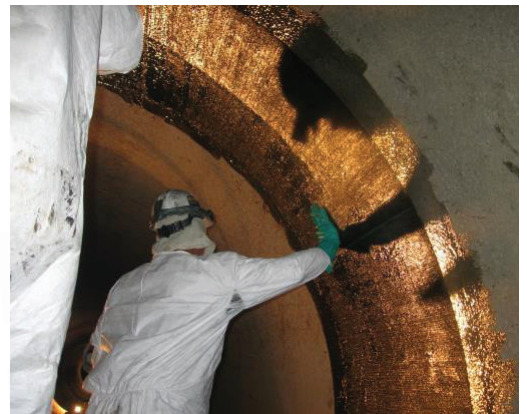
An examination of a 9-foot diameter prestressed concrete cylinder pipe (PCCP) carrying water from the Colorado River to southern Arizona revealed a number of sections with broken prestressing wires. Due to the extended downtime and excavation costs, replacement of the pipes was not an attractive solution.

Wrapping the interior of the pipes with DowAksa CarbonWrap® seemed to be a very cost-effective and attractive solution. It was presented to the client and was selected as the method of choice for the pipe retrofit project.

Approximately ten pipe segments were strengthened using DowAksa CarbonWrap® technology on time and within budget for the Central Arizona Project Authorities.
