**DOWAKSA** CarbonWrap®

## CASE STUDY

THE MEETING HOUSE BRIDGE  
WESTERLY, RHODE ISLAND

### TWO-SPAN ARCHED BRIDGE RESTORED

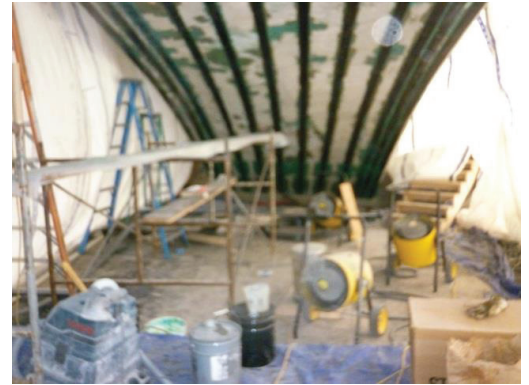
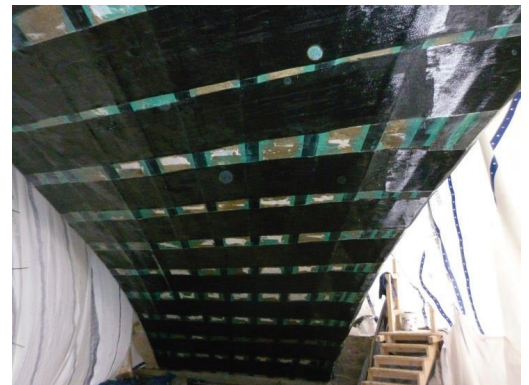
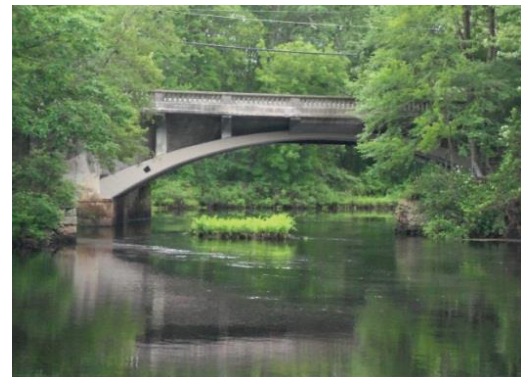
Due to recent floods, the two-span arch bridge near Westerly, Rhode Island, had been severely damaged in several areas. This damage also compounded the deterioration due to many years of use without adequate maintenance. The state implemented an emergency repair program for the bridge and identified the DowAksa CarbonWrap® technique as the best solution to achieve the repair objectives in the shortest possible time.

DowAksa CarbonWrap® designed and installed a unique solution, combining carbon laminates and fabric to strengthen the bridge for shear and flexural forces. The majority of the work was conducted during the months of November and December; therefore, the bridge had to be tented and heating devices used to bring the temperature up to acceptable levels. The project was successfully completed in time, and it met all design objectives and testing.
